CHAPTER 5: DATA RECOVERY EXCAVATIONS

As described in the Methods section of this report, data recovery operations were conducted as a scheduled task of within the overall bridge removal process. A cofferdam was constructed around the site, and the flow of Gravelly Run was diverted into a 48-inch-diameter metal culvert (Figure 42). This produced a relatively dry environment within which to remove the fill and structural members associated with the 1936 bridge and to examine the archaeological remains of the milldam and earlier mill-related features.

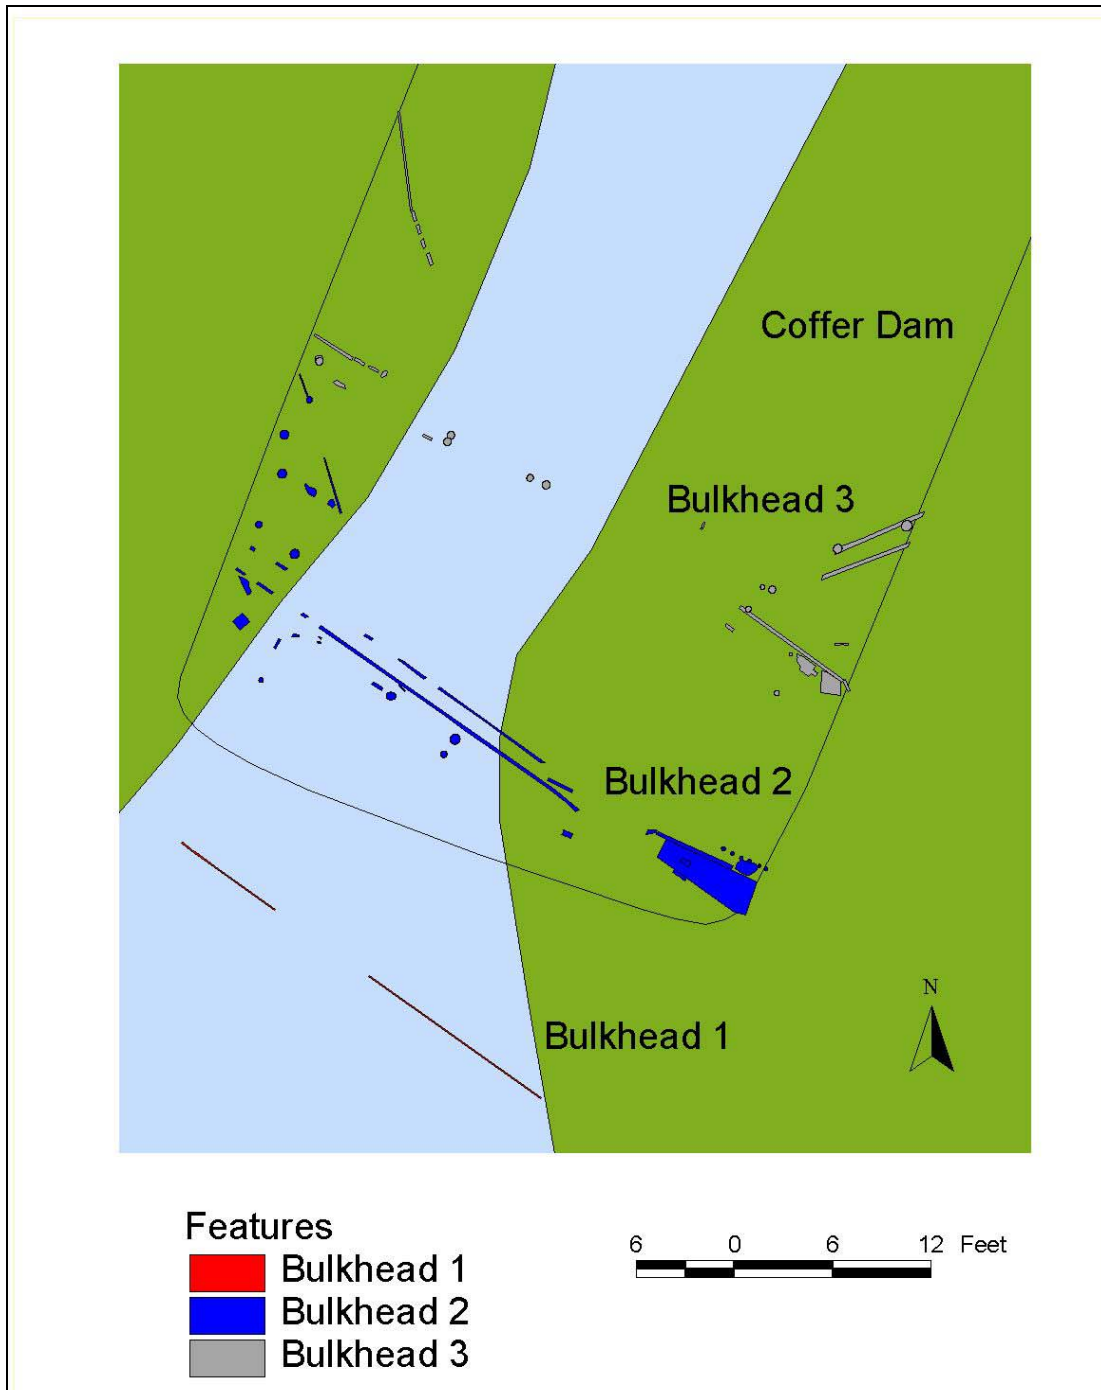
Figure 44: Planview of Bulkheads

The material of greatest archaeological interest lay beneath the bridge fill and recent floodplain deposits, in the form of wooden features that appeared to be connected with pre-20th century water control. The remainder of the archaeological descriptions will detail these features. The features were numbered arbitrarily in the field, in order of discovery. Further analysis has shown that there is a logical order to the features that supercedes the field numbering system, and so the features are grouped for this presentation according to their apparent association. In general, the features appeared to be associated with three parallel bulkheads that extended across the width of the stream channel. A list of the groups and their constituent features follows in Table 6. A plan view of the cofferdam excavation showing the bulkheads is shown in Figure 44.

Bulkhead 3 consisted of discontinuous fragments of sheet piling that stretched across the channel of Gravelly Run, along with fragments of wing walls extending upstream from both the east and west ends (Figure 44). While most of the individual features comprising the bulkhead were poorly preserved, the accumulated data from the remnants suggested that construction techniques were similar to those observed in

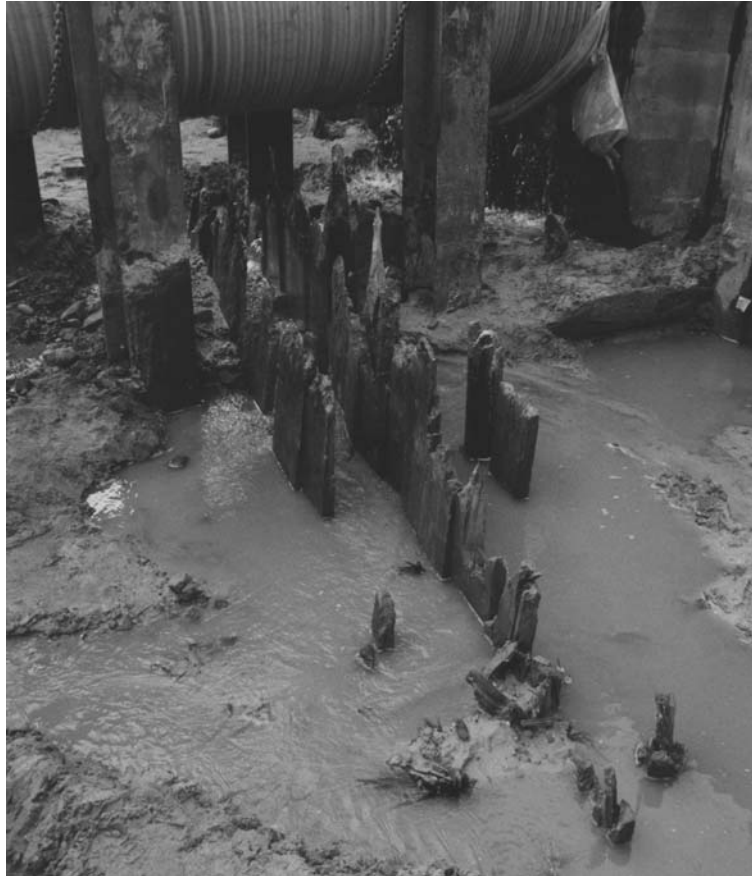
Figure 46: Central portion of Feature 2, underneath the diversion culvert. Facing Southeast.

place and the flow of Gravelly Run diverted into the metal culvert. The deteriorated wood, originally identified as short segments of parallel planking, was indeed part of Bulkhead 2. Excavation revealed two sets of sheet piles. The longest was roughly aligned with the portion of the bulkhead to the east (described above). It extended 19 feet from the gap east of the stream channel (caused by the east bulkhead of the 1936 bridge), to a point at which it was truncated by the west bulkhead of the 1936 bridge. After a space of approximately 4 feet, the remaining sheets of Bulkhead 2 appeared, extending westward to the wall of the cofferdam. This part of the bulkhead was excavated as Feature 16. Three posts, Feature 19 (6 inches in diameter) and Features 25 and 26 (3 inches in diameter), were located south of, or downstream from the sheet piles, serving either as supports or alignment posts.

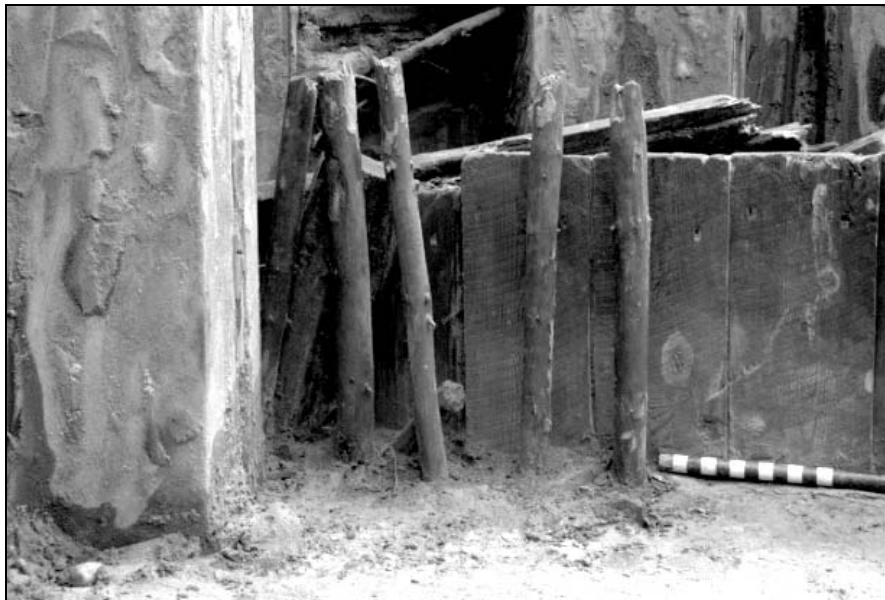
Figure 48: East End, Bulkhead 2, Feature 2, Crash Rack. Facing South

At the east end of the feature, near the point at which it was truncated by the cofferdam, there was a formal break in the sheet piles. A series of 2.5-inch-diameter pinewood posts had been placed across the opening to form a grate, designed to catch large debris. One of the posts was removed for examination and was found to measure 54 inches in length, with the end trimmed to a point for driving into the subsoil. A large, 7-inch-diameter post was also present in the gap. It probably served as support for the large reinforcement timber, although both the post and timber appeared to have been displaced when the timber was pushed down and twisted by the force of the cofferdam sheeting. The opening in the sheet piling was at least 2 feet wide (the east end was truncated by the cofferdam). Debris, such as twigs, leaves and roots, lay in a dense mat against the base of the bulkhead. The material was particularly dense against the grate, and subsoil was washed out in a wide basin upstream from the opening, where water had eroded the sandy bottom deposits as it streamed through the opening.

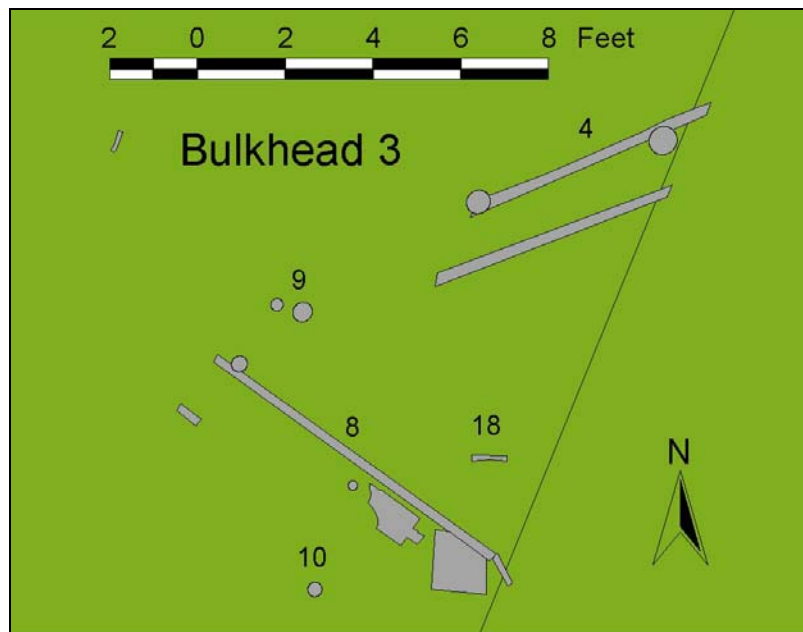
Figure 52: Bulkhead 3 on East Side of Stream Channel

The components of the bulkhead were fragmentary; they were investigated and documented separately, given individual feature numbers as they appeared during excavation. The bulkhead pilings on the east side of the stream channel were designated Feature 8, and the corresponding posts were labeled Features 9 and 10 (Figure 52). The associated wing wall fragment on the east side of the stream was recorded as Feature 4. West of the stream, the sheet piles occurred in two sections, designated Features 11 and 17. Feature 12 was an associated post, while the wing wall on the west side was designated Feature 5. Scattered posts near the middle of the stream channel were designated Features 6 and 21. There were no surviving sheet piles from Bulkhead 3 in the stream channel.

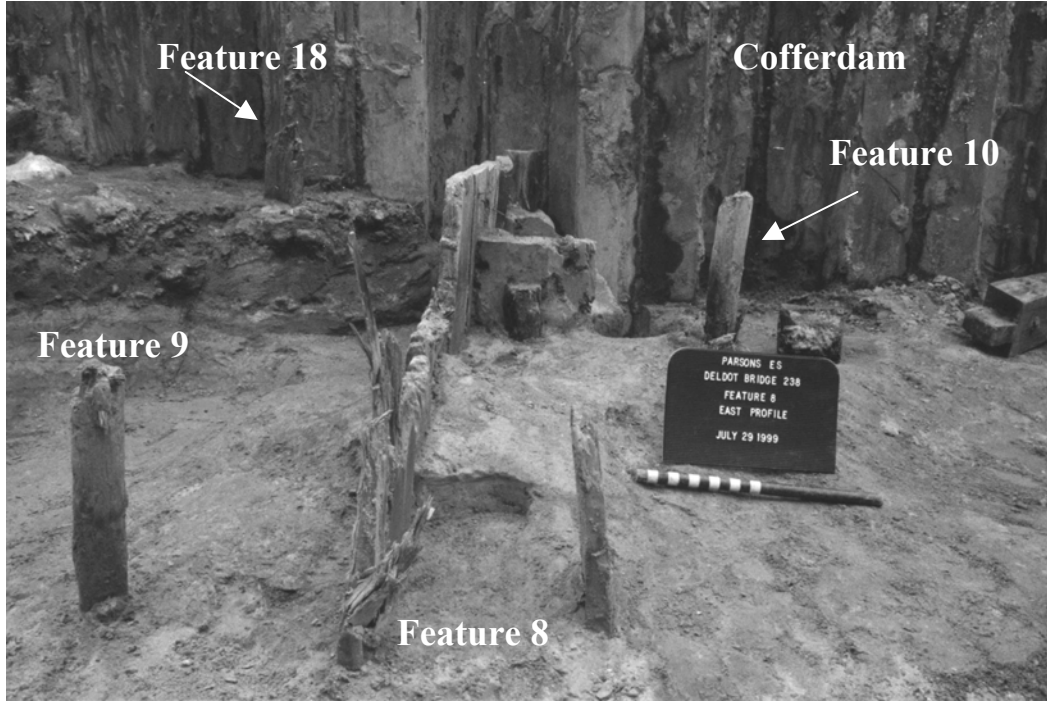
Figure 54: Bulkhead 3, Feature 8, Facing East.

Feature 8 consisted of a series of sheet piles, oriented parallel to Feature 2 (Figures 53 and 54). The planks measured 2 x 10.5 to 2 x 12 inches, and had been driven into the stream bottom and cut flush at or near present mean sea level. Like the sheet piles in Feature 2, these planks had been single-beveled to force them together as they were driven into place. They were shorter than the planks in Feature 2, measuring about 5 feet in length. Circular saw marks were visible on the plank faces. Estimates of the diameter of the saw were made both manually and mathematically (measuring the rise and chord): the estimated blade diameter was 35 to 45 inches. Two-foot diameter circular saws were introduced in the US in 1819; they were common in Maryland by the 1830s and 40s (Marsh 1998).
